RESCUED FROM THE BRINK: RESTORATION OF EELGRASS,

ZOSTERA MARINA, TO THE UPPER NEW YORK BAY

Urban Assembly New York Harbor School
Marine Biology Research Program

2015

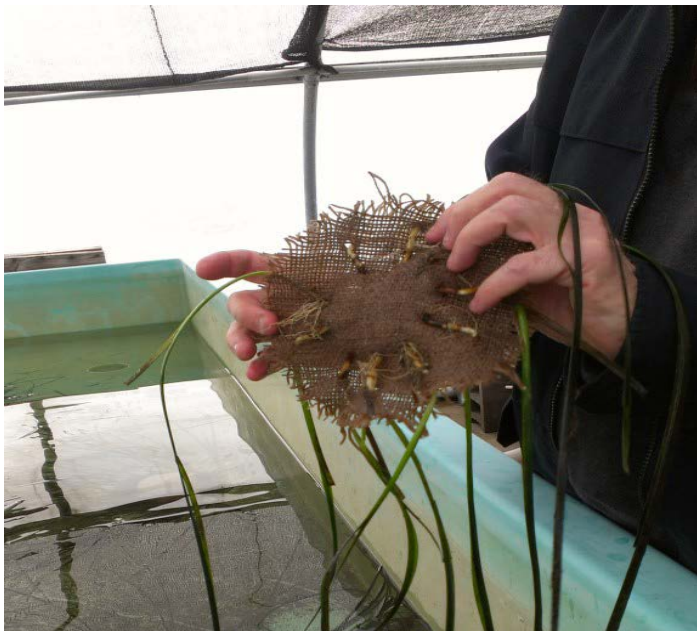
Image 1: Burlap "Tortillas" of Eelgrass before Planting

- 1) Enlarge openings of the 8" burlap circle such that there are space for 20 shoots, with 2 openings per shoot.
- 2) Weave 20 eelgrass shoots through openings.
- 3) Place "tortillas" (burlap circles) in tank until use.

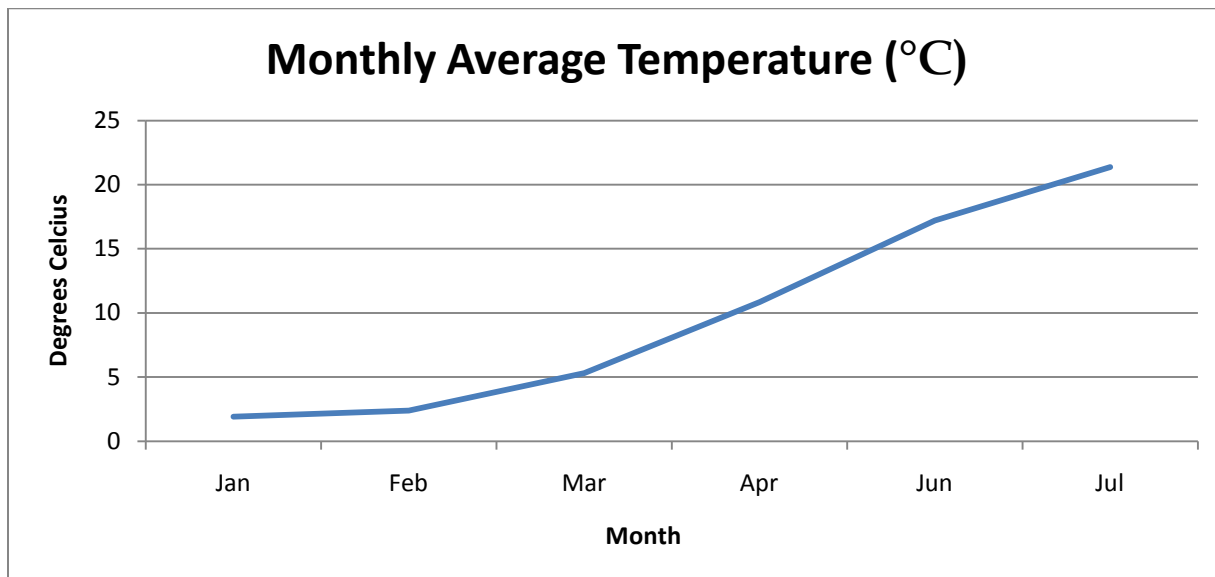
Figure 3: Average Monthly Temperature (in °C). The highest temperature exceeded the tolerance level of 20°C.

The survival of Eelgrass weighs heavily on the temperature of the water it is in due to the fact that this played a large role in its decline and susceptibility to *Labyrinthula zostera* (Muehlstein, 1989). As expected, temperatures are highest in the summer, even exceeding the 20°C tolerance level. (Schott, pers. comm., 2012). Despite a maximum temperature of 24°C, the eelgrass continued to survive. Despite high temperature, the eelgrass did not decline greatly, leading to the conclusion that there were not any other factors present to add onto the stress imposed by unfavorable conditions.

Temperature, although occasionally falling outside the tolerance levels of eelgrass, has normal seasonal changes. There is a concern that the stress imposed by the high temperature and that imposed by possible light-limiting nutrient loading may cause a decline in eelgrass.

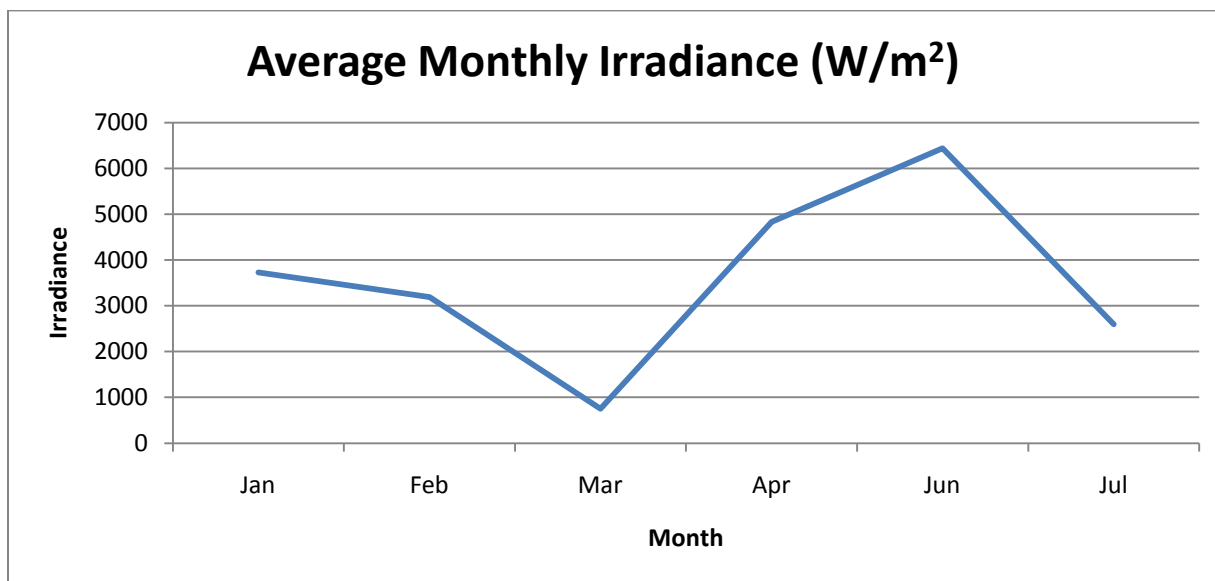
Figure 4: Average Monthly Light. Data was originally measured in Lux, but was then converted to Irradiance using a conversion factor of 4.02 and has a unit of Watts per meter squared of surface. Light was lowest in March and increased into the summer. Light decreased in July, but is attributed to associated organisms on the logger, limiting light penetration.

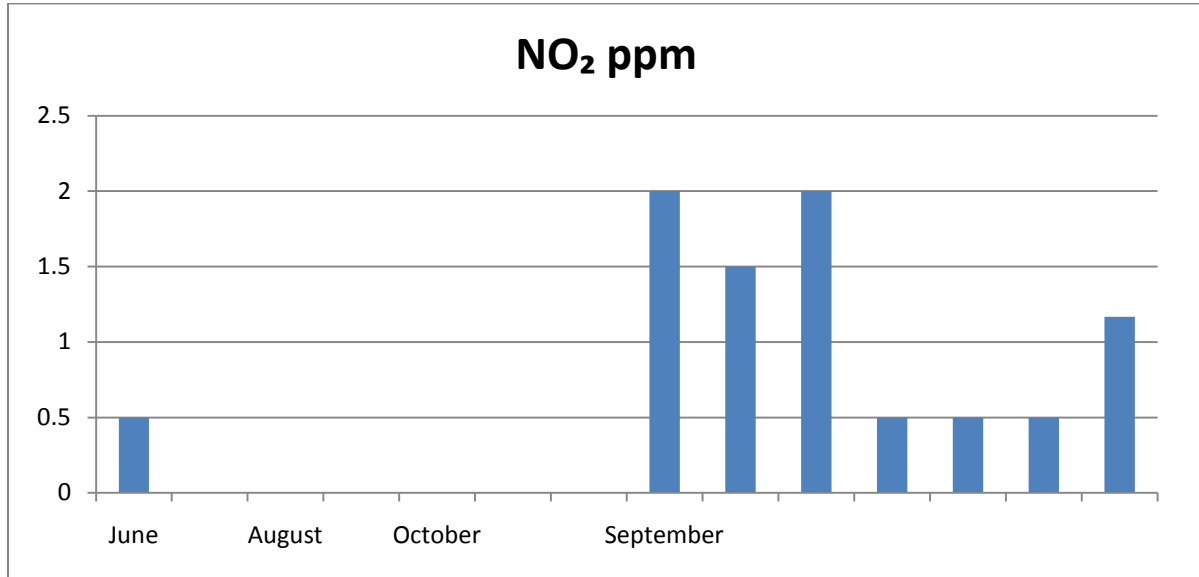
Figure 5: Nitrite levels fluctuate as the year goes on, lowest in the Summer and Highest in the Winter.

Winter marks a transitional point for both Nitrites and Nitrates, where the levels begin to drop from their summer highs. Nitrates and Nitrites are used by plants to complete bodily processes (Gonzalez, pers. comm., 2012). Seasonal changes are most probably due to eutrophication, there is a Combined Sewage Overflow near the site and discharge may cause increases in Nitrate and Nitrite, but from our observations the change is not so drastic that it creates an unstable environment.

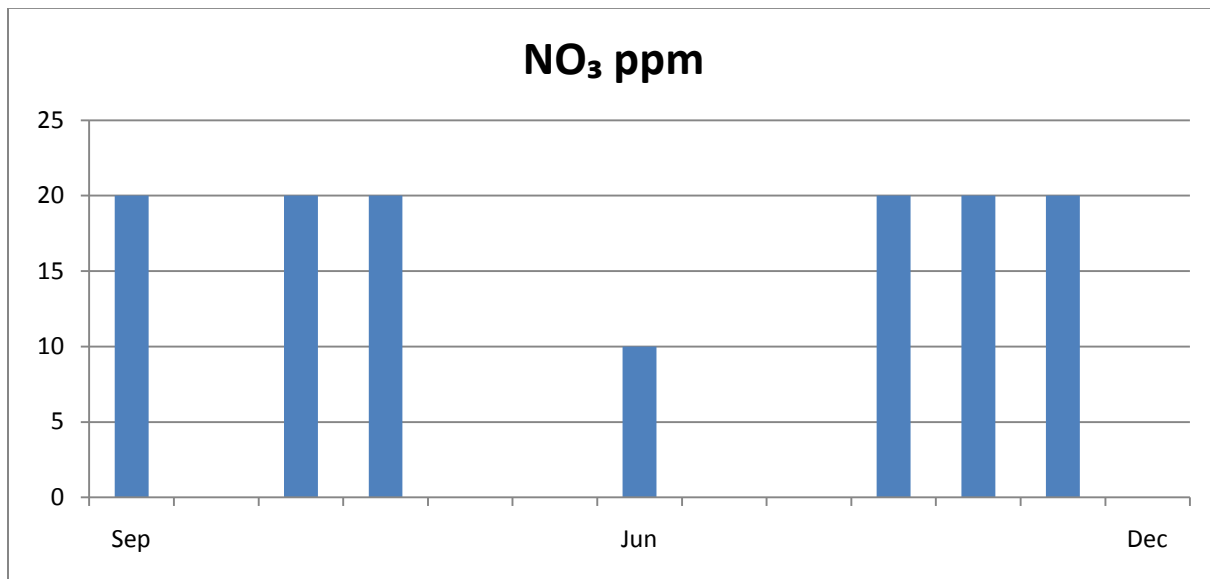
Figure 6: Nitrate measurements. Values fluctuate seasonally with peaks in the Fall and low-points in the Summer and Winter.

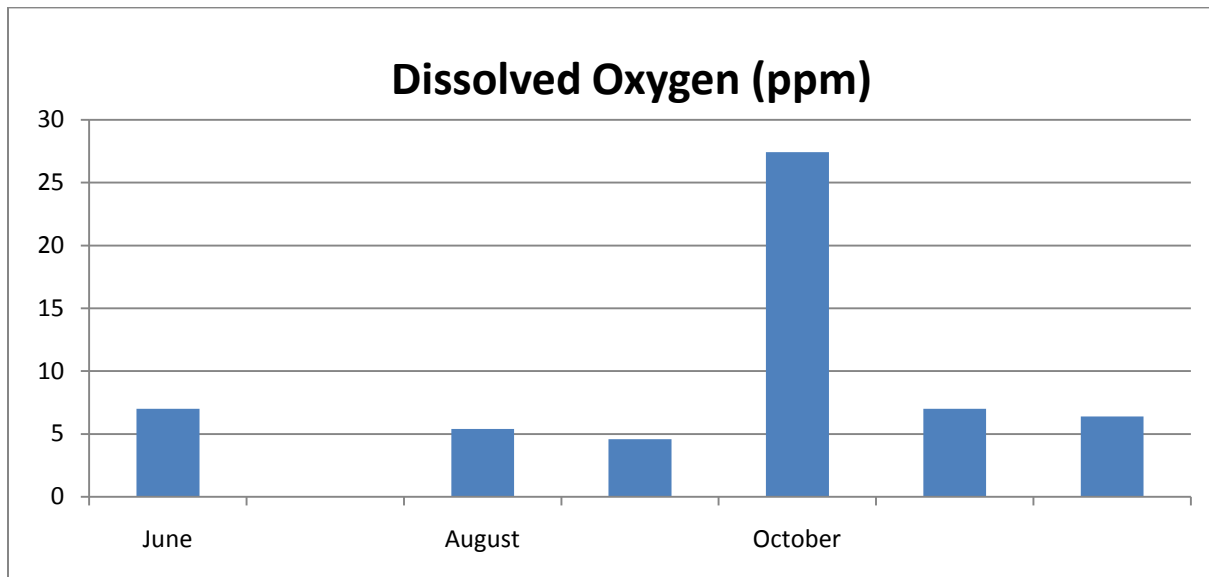
Figure 7: Dissolved Oxygen. Not enough values have been recorded to make conclusions about cyclic behavior.

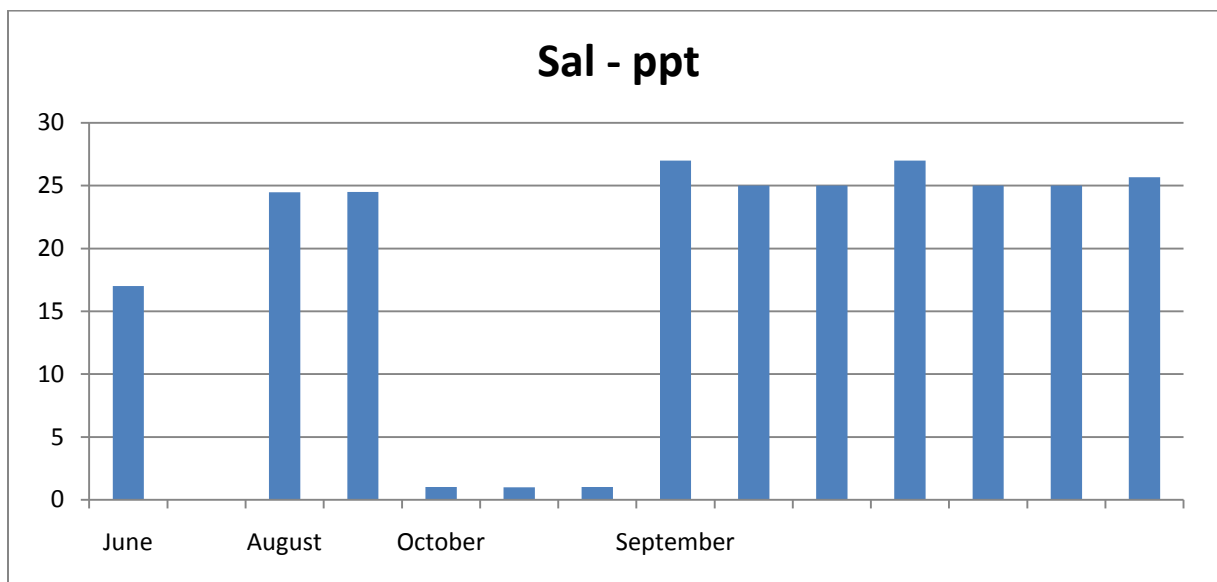
Figure 8: Salinity. Values measured differ due to differences in tide during visits.

The salinity of the water changes with tide due to the fact that the site is in an estuary. Seasonal cycles cannot be identified as tidal height differs from one visit to the next. When it floods the salinity rises, and when it ebbs the salinity decreases. This is due to the fact that when the estuary floods, there is more water coming in from the salt water ocean, and when it ebbs there is more water coming from a freshwater source. This does not affect the Eelgrass in this area because the fluctuations do not reach extreme levels (Schott. pers. comm., 2012).

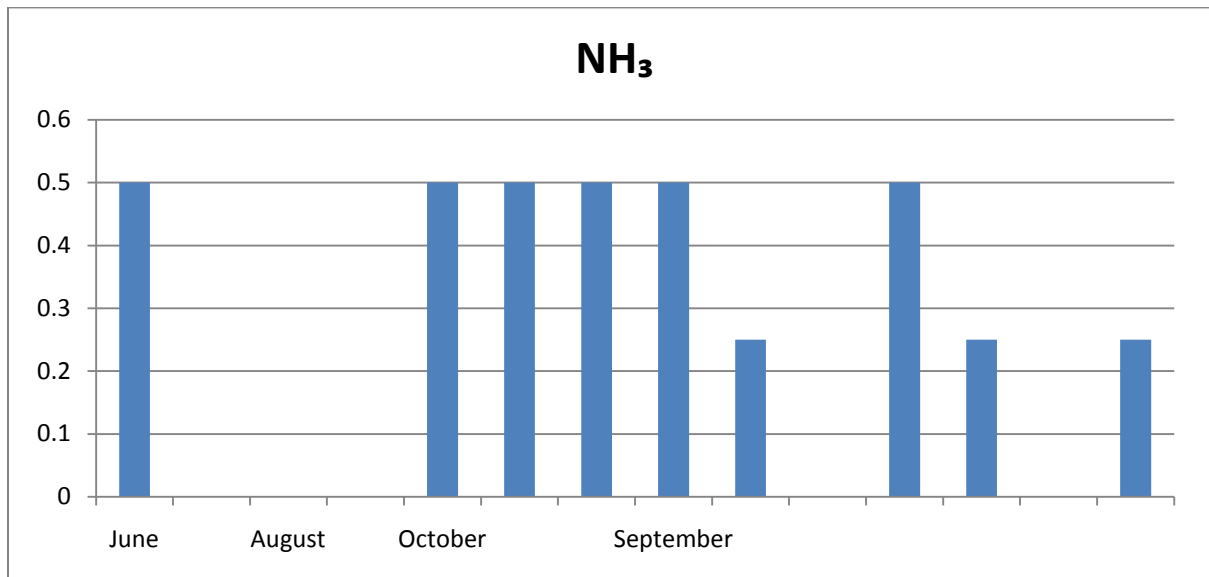
Figure 9: Ammonia measurements remain relatively constant through all visits.

Ammonia, the waste product of plants having used Nitrite and nitrate, remains relatively constant from one measurement to the next. Despite nitrate and nitrite changing seasonally, ammonia remains the same. The reasoning for this distinction is unclear.

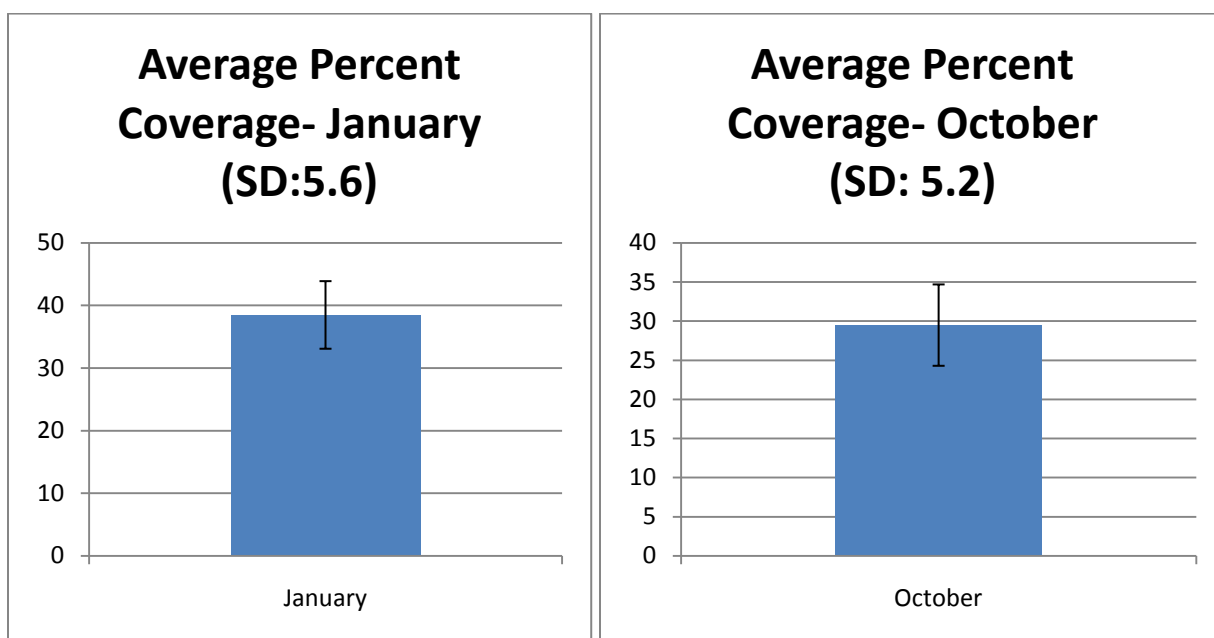
Figure 10: Average Percent Coverage as determined by the use of the quadrat. January had approximately 38.5% cover (SD: 5.6) and the following October has approximately 29.5% cover (SD:5.2)

The average is used due to there being slight variations in the sections visible as a result of suspended sediment. Upon assessing images from the quadrat, an average percent coverage of 38.5% (SD: 5.6) can be seen during January. In October, there was an average percent coverage of 29.5% (SD:5.2). The eelgrass had only lost 7% during the 9 month period. With standard deviation considered, it is determined that the percent change was not significant. The patch of eelgrass observed was at 72cm below low-tide. Observations indicate that eelgrass planted at shallower and deeper depths did not survive as well as eelgrass planted at 72cm below low tide. It is possible that eelgrass planted deeper did not get enough light and eelgrass planted in shallower water was either exposed during low tide or was unable to root properly as a result of waves upsetting the sediment.

The eelgrass had only decreased 9% during the 9 months between January and October. Having maintained upwards of 20% coverage for a period of time exceeding 2 months, the eelgrass planting was a success. It even survived the summer where mudsnail egg casings and temperatures above 20°C. With standard deviations considered, the 9% loss was not significant and the eelgrass has maintained its percent cover. The 72cm depth was optimal for the survival at eelgrass at this site, considering eelgrass planted both deeper and shallower did not survive as much as that planted at 72cm below low tide. This indicates an ability to survive at the site long-term.
