Rescued from the Brink: Eelgrass Restoration to NY Harbor

Presented by: Nicolle Martinez

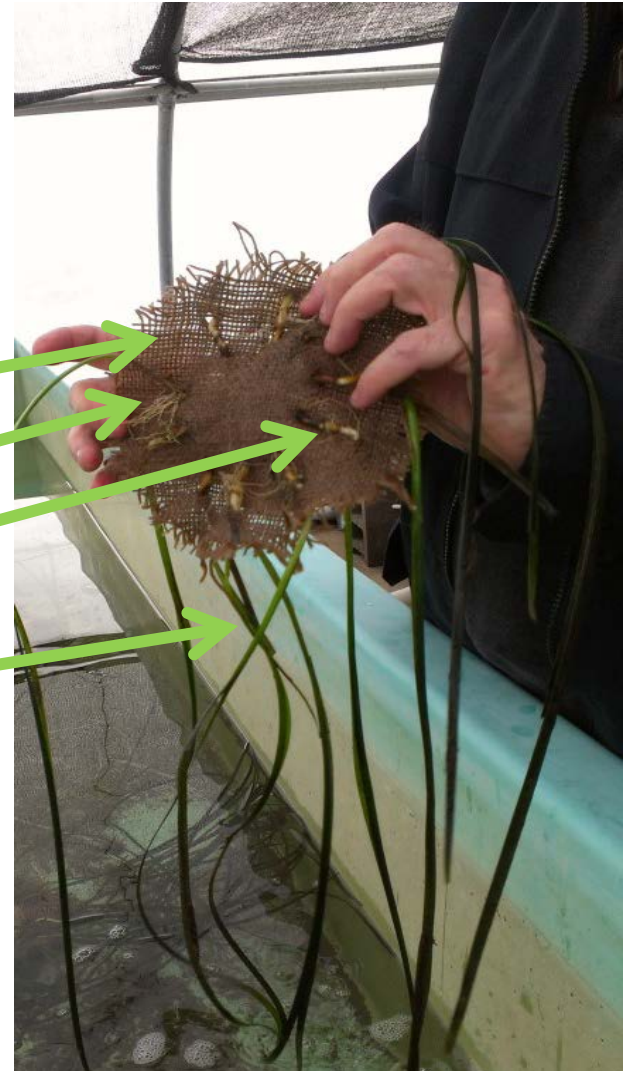
- Grows similar to terrestrial grass; horizontal to the surface.
- Blades must be <75% buried to survive (Mills; Fonseca, 2003).

8" Burlap "tortilla"

Roots

Rhizome

Blade

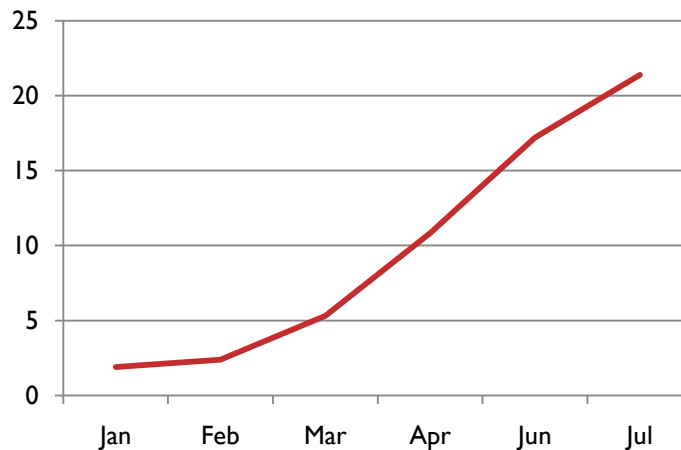
Monthly Average Temperature (°C)

Figure 2: Average Monthly Temperature (°C). The highest temperature exceeded the tolerance level of 20°C.

- Temperature remained near the tolerance level of 20°C despite exceeding it, reaching as high as 24°C.
- The 72cm depth was optimal for the survival of eelgrass at this site. Indicates an ability to survive at the site long-term.
- Having maintained upwards of 20% coverage for a period of time exceeding 2 months, the eelgrass planting was a success.

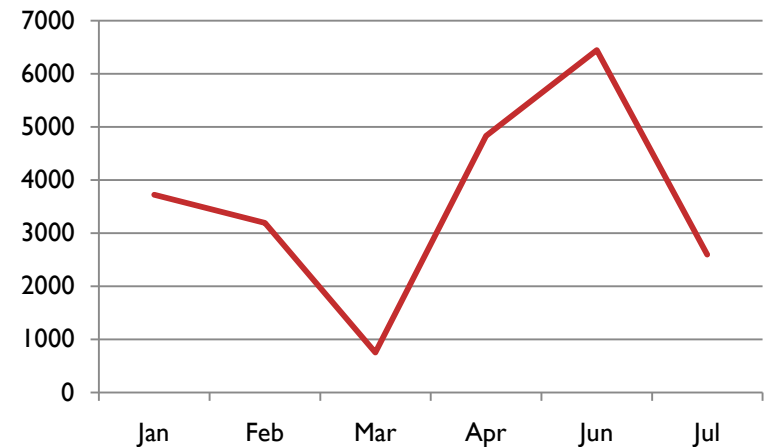
Average Monthly Irradiance (W/m²)

Figure 3: Average Monthly Light. Data was originally measured in Lux, but was then converted to Irradiance using a conversion factor of 4.02 and has a unit of Watts per meter squared of surface.

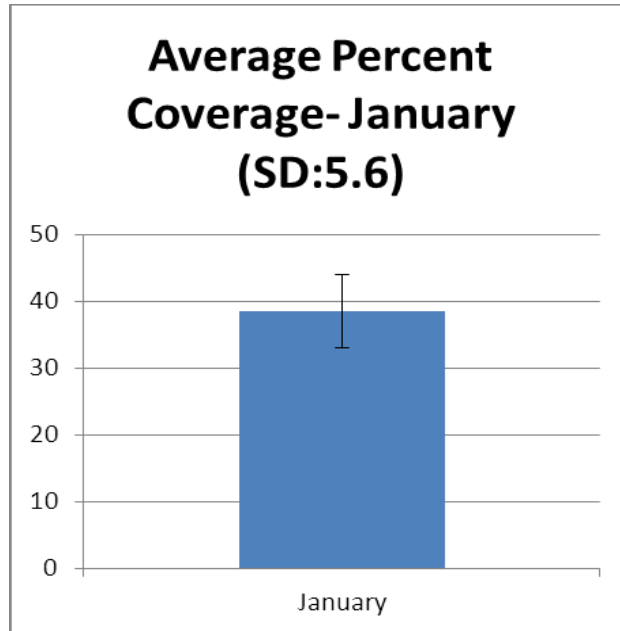
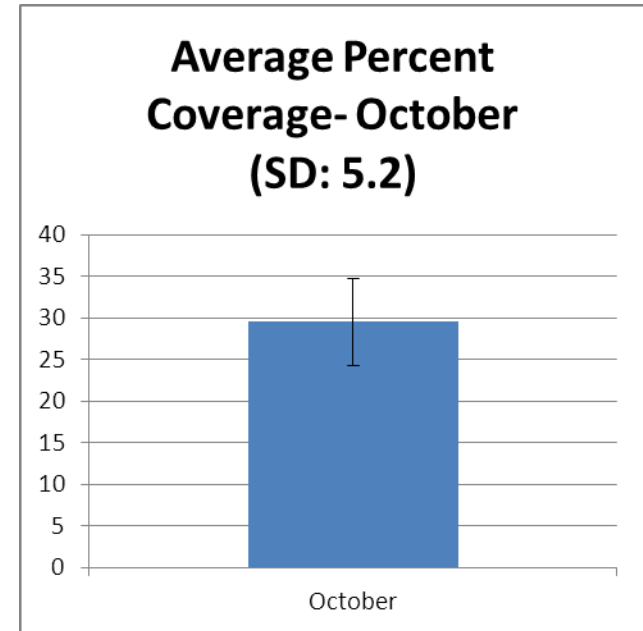
Figure 6: Average Percent Coverage as determined by the use of the quadrat. January had approximately 38.5% cover (SD: 5.6) and the following October has approximately 29.5% cover (SD:5.2)
